# **INCIDENT INVESTIGATION FINAL REPORT**

## **RLUOB TOPPLED LOAD**

### **Near Miss to Personnel Injury**

**May 21, 2019**

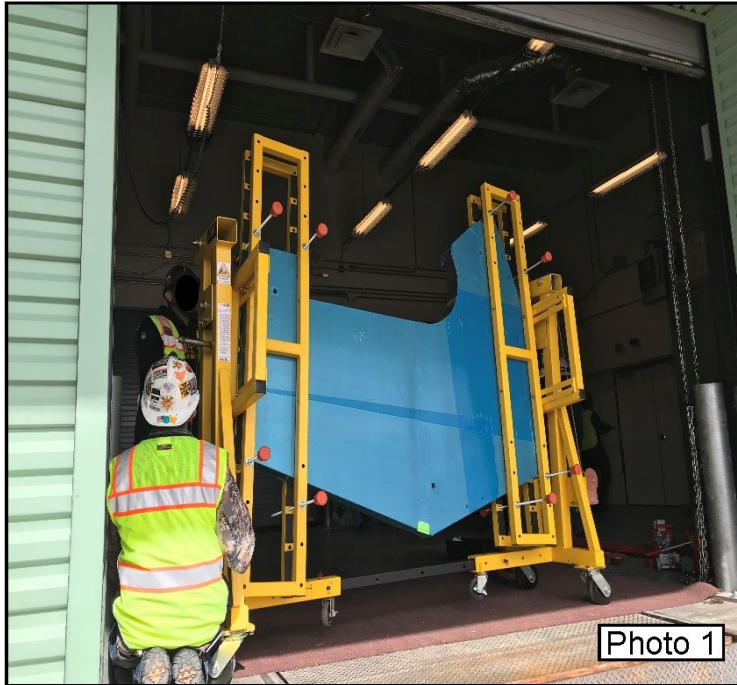
table to an upright vertical position, then raised and lowered the table to verify stability of the load. **Photo 1** was taken once the load was stabilized.

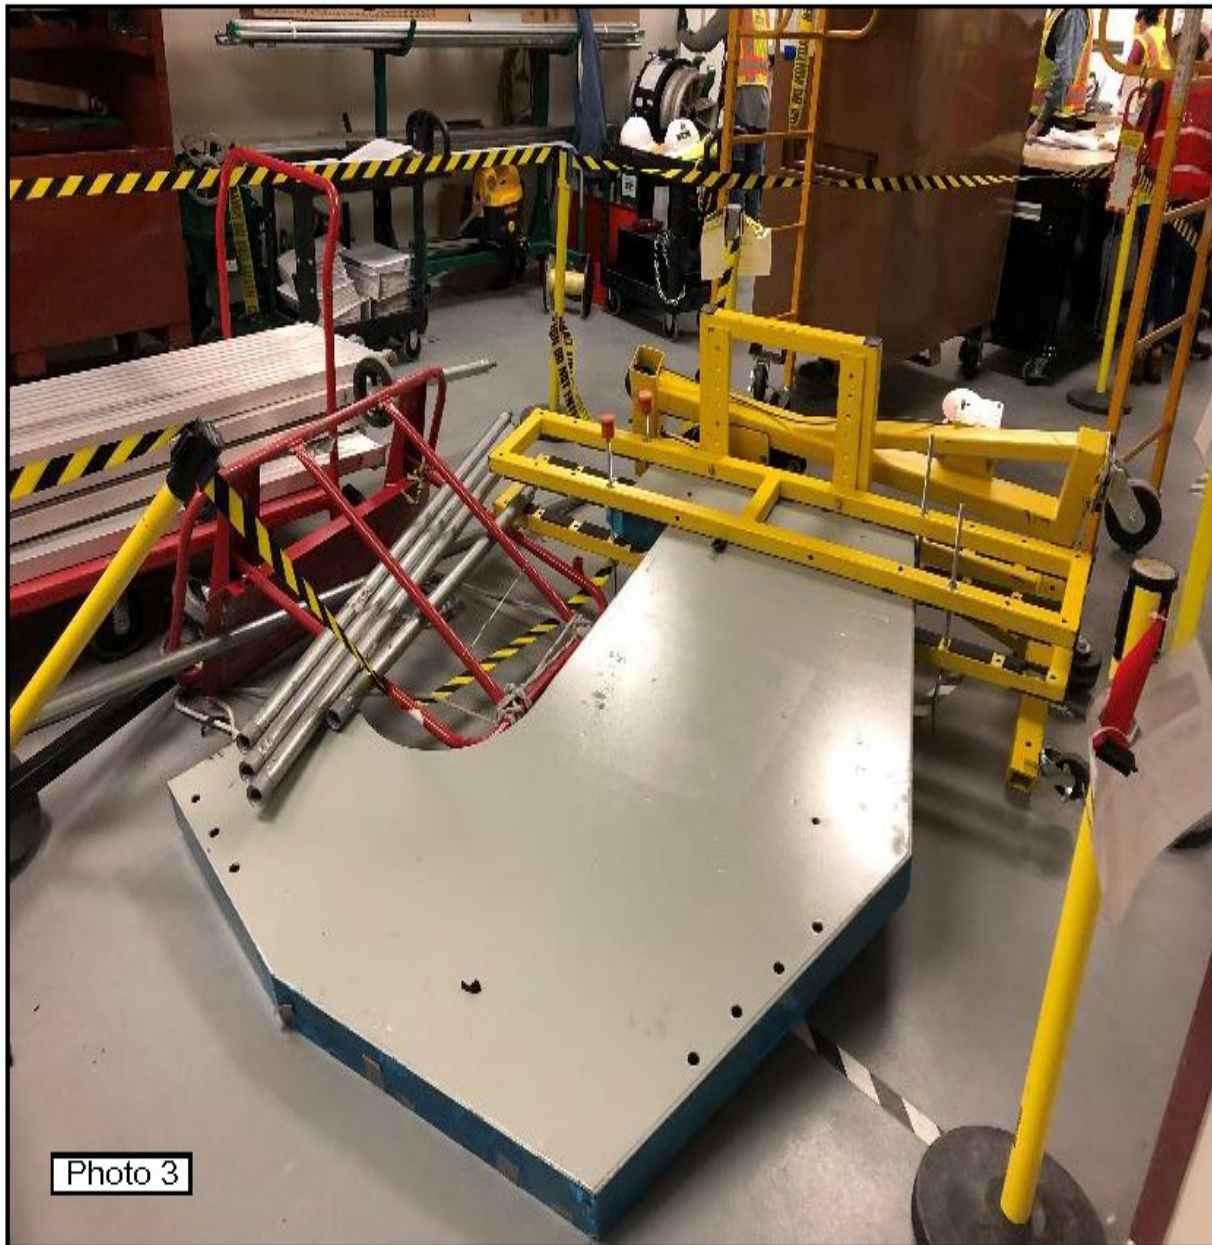
Approximately 10 feet along the path, the lifting device and load fell over as seen in **Photo 3**.

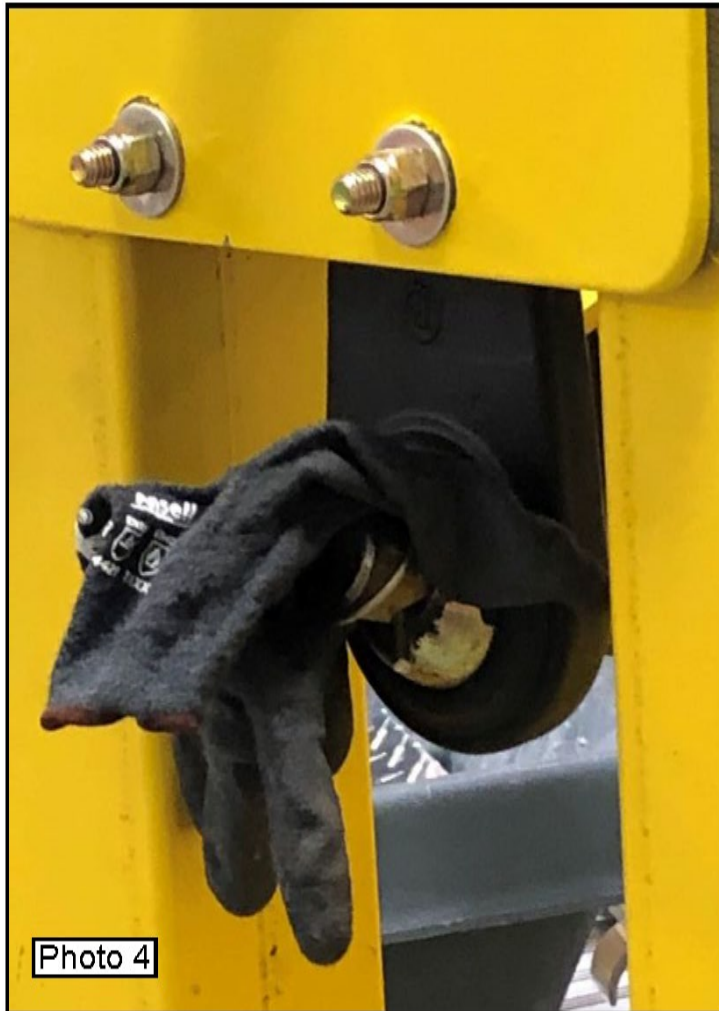
However, one of the H&R supervisor's safety gloves was caught and remained in the lifting device assembly as seen in **Photo 4**.

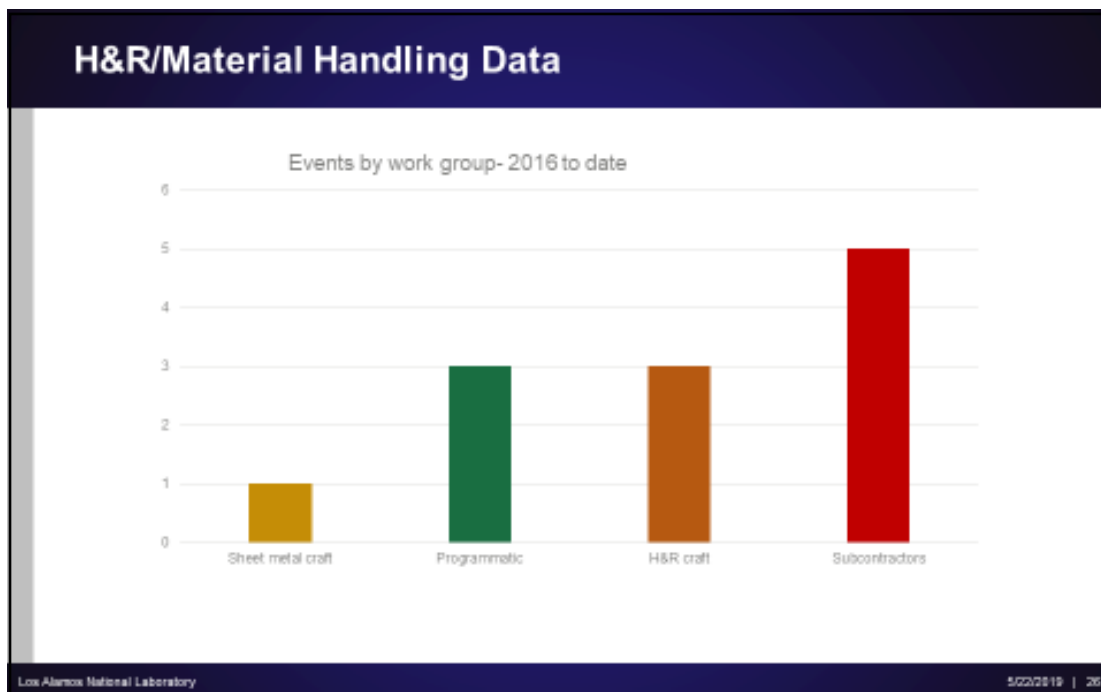
**Figure 1**

A review of eleven other ORPS and sub-ORPS events was performed by the investigation team. This review revealed several conditions associated with management systems and work execution that existed across the Laboratory, including programmatic work, Laboratory craft H&R and material move work, and subcontract H&R and material move work. Of 12 events total (including the RLUOB toppled load) spanning from 2016, most reportable events involved subcontractors. Five of the 12 events involved subcontract work to include two events that occurred in close succession with the same subcontractor. Three events involved programmatic personnel and two involved the Logistics H&R craft. One other event involved sheet metal craft. See **Figure 1**.

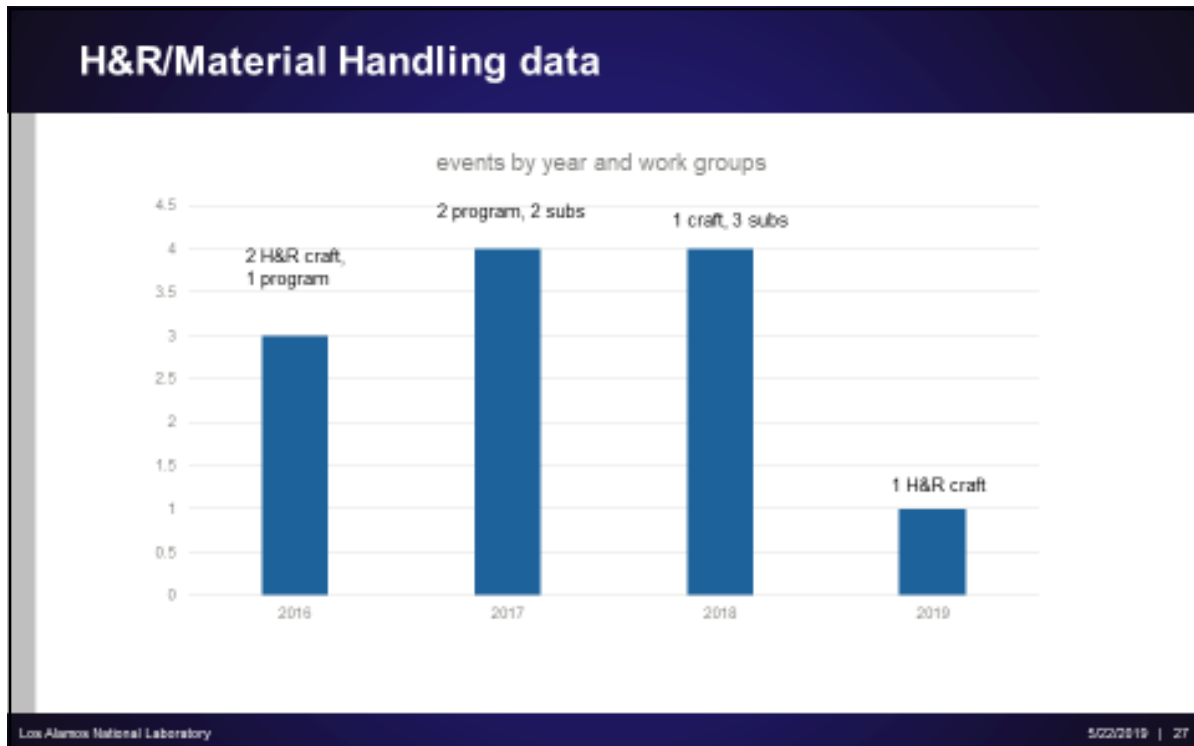
**Figure 2**

These events were distributed over time as follows: two events occurred in 2016, four in both 2017 and 2018, and one (to date) in 2019. The type of work that is executed by the LANL H&R crew was reviewed in order to understand (a) total H&R work activities in light of total reportable events, and (b) lift plan categorization trends. See **Figure 2**.

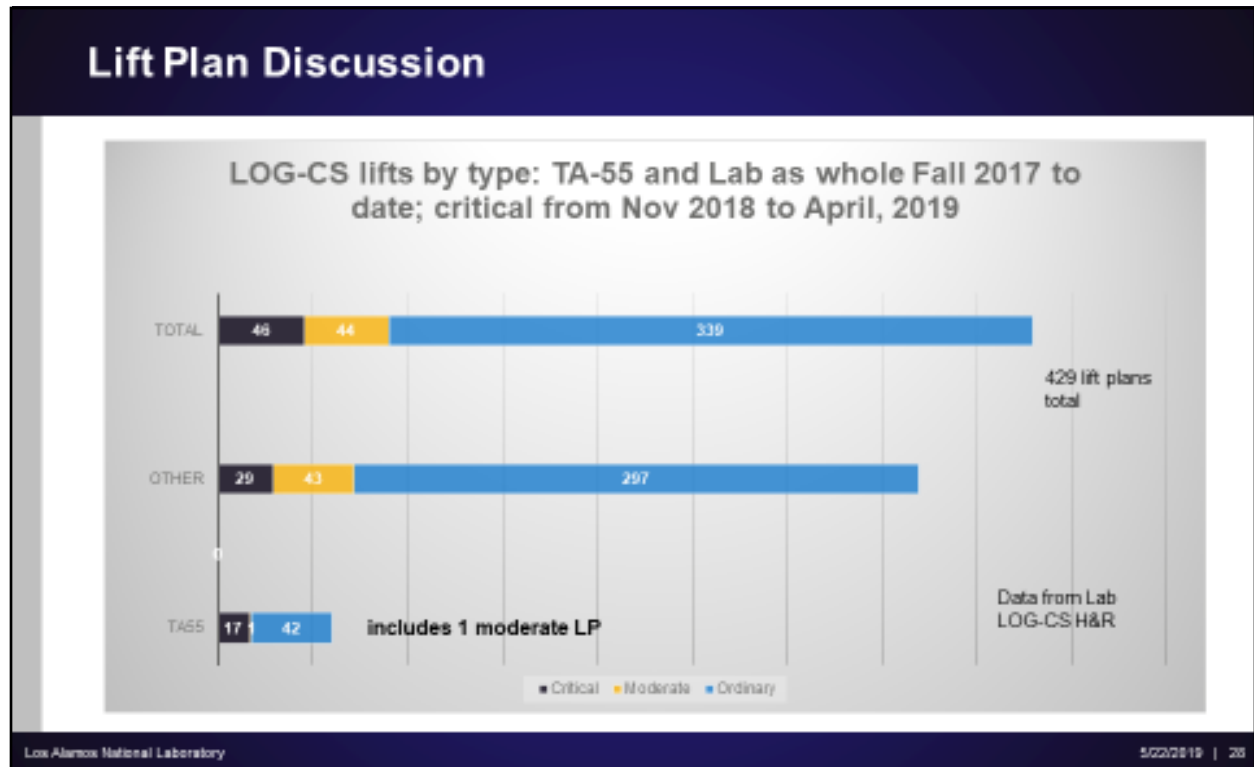
Figure 3

The Logistics H&R department provided 429 lift plans for review from across the Laboratory. These lift plans were for TA-55 and the Laboratory as a whole from the fall of 2017 to the information request date. The set of lift plans included critical lift plans from November of 2018 to the request date. Of all 429 lift plans, 60 were associated with TA-55. Of the 60, 42 lift plans or 70% of them were categorized as ordinary lifts. For the Laboratory as a whole, including TA-55, 339 of 429 lift plans or 79%, were categorized as ordinary. See **Figure 3**.

The data reflects an overwhelming use of the ordinary categorization, which, as discussed previously, involves less specific work planning requirements and plan content requirements that may adversely affect work execution if the lift is more complex. The data reviewed demonstrated two reportable events for 429 lift plans.

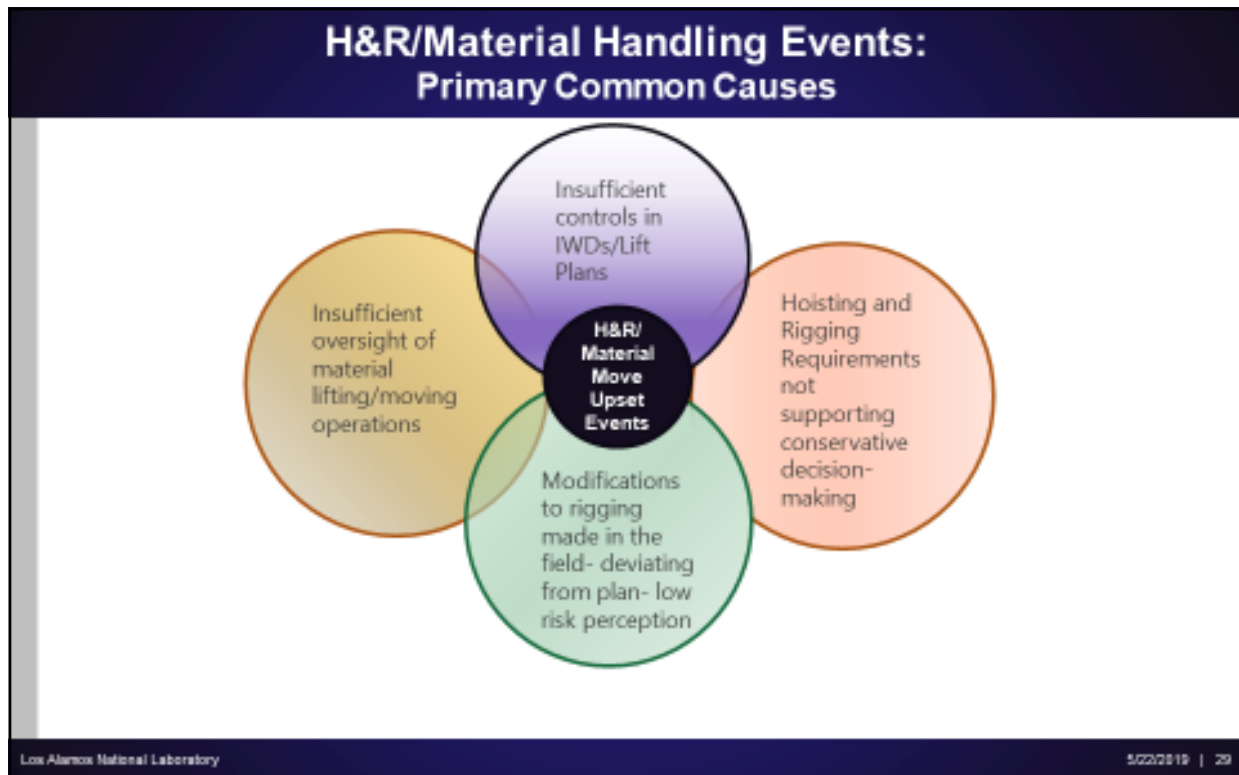
**Figure 4** illustrates the interrelationship of the primary common causes of material handling events.
